## Lessons from New Orleans for the design and maintenance of flood defence systems

W. Kanning, S. van Baars, P.H.A.J.M. van Gelder & J.K. Vrijling

**ABSTRACT:** The flood disaster of New Orleans due to hurricane Katrina in August 2005 can provide valuable lessons for the design and maintenance of European flood defence systems. The system partially failed because the design conditions (water levels, waves) were exceeded by the hurricane. The other part of the system failed at water levels below design level due to geotechnical failure of the floodwalls' foundations. The disaster showed the importance of a careful determination of design conditions, the significance of transitions and objects on the slopes and it showed that geotechnical failure is of major importance for the reliability of flood defence systems.

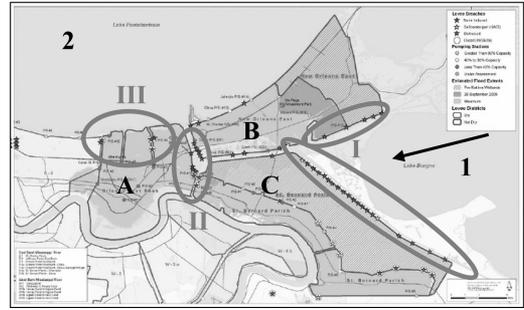
Figure 3. Flood defence system in New Orleans (modified after ILIT 2006).

- 1 Erosion of the flood defences along Lake Borgne ('I' in Figure 3). These flood defences mainly consisted of earthen embankments and were destroyed for many kilometres because the flood defences were not high and strong enough to withstand the water levels and waves.

- 2 Failure of flood walls and scour around transitions. The high water levels in Lake Borgne progressed into the shipping canals that connect the Mississippi with Lake Pontchartrain and the Gulf of Mexico. The floodwalls were not high enough or the transitions between soils and solid structures were not strong enough and erosion due to overtopping caused several failures. ('II' in Figure 3).

- 3 Geotechnical failure of floodwalls along dewatering canals ('III' in Figure 3). The wind induced high water levels along the south shore of Lake Pontchartrain progressed into the dewatering canals that enter the city. The floodwalls along these canals

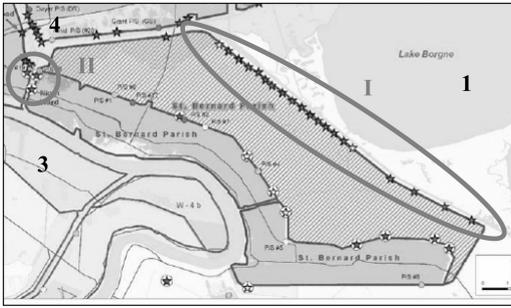
Figure 5. St. Bernard dike ring (modified after ILIT 2006).

The St. Bernard dike ring is situated on the eastern part of the city, with Lake Borgne on its east side ('1' in Figure 5), the Mississippi on its southwest ('3') and shipping canals on its north and west side ('4'). The dike ring is mainly inundated due to two causes:

- 1 Failure of many kilometres of earthen embankment due to overflow and wave overtopping ('I' in Figure 5)
- 2 Failure of two floodwalls after wave overtopping ('II')

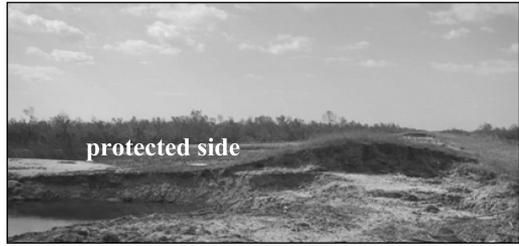
A significant part of the 20 kilometre long earthen embankment along Lake Borgne failed. The wind set-up caused a storm surge in combination with high waves. This completely overloaded the defence, resulting in multiple breaches. The water levels exceeded the design levels by many decimetres, causing the embankment to scour away on many locations (see Figure 6). Although the system was designed on a design storm with an estimated return period of 200–300 years (in the 1960's, based on GAO 2005), the design level was exceeded. There is no consensus yet what the actual return period of hurricane Katrina was, but it seems less than the estimate. Besides the exceeding

Figure 6. Breached embankment in St. Bernard dike ring (ILIT 2006).

water levels, there was no protection of the outer slope of the embankment to prevent the waves from eroding the slope. In Dutch codes and recommendations, the erosion resistance of the revetment is of major importance and stone layers or other protection systems are usually applied to protect the slope (TAW 1998).

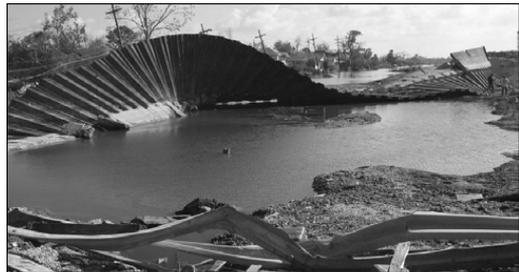
Figure 7. Failed floodwall in St. Bernard dike ring on the Lower Ninth Ward site (IPET, 2006).

The second major group of failures that caused inundation of the St. Bernard dike ring, was the failure of two floodwalls near the Lower Ninth Ward. The high water levels in Lake Borgne progressed into the shipping canals, causing a severe load on the floodwalls surrounding these canals. The scour holes behind neighbouring floodwalls indicate that considerable quantities of water flowed over the walls. Most probably the earth behind the floodwall was scoured away, after which the floodwall lost its strength and was pushed away by the water, see Figure 7. The effects of these two failures were more severe than the overflowing of the embankment, since the floodwalls collapsed suddenly. Many casualties were found in the areas behind these two breaches.

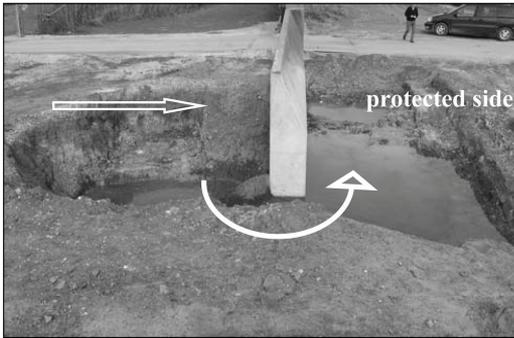
Figure 8. Scour around a transition from floodwall to earthen embankment.

Pontchartrain on the north and east, by Lake Borgne on the south and by shipping canals on the south and west. Besides the erosion of earthen embankment along Lake Borgne, similar to the failure described in section 4.1, we can observe many failures around transitions between solid structures (floodwalls, doors, sheet piles) and the earthen embankment. A few floodwalls failed as well, similar as described in section 4.2. The flow around such a transition is contracted, resulting in increased flow velocities and turbulence, causing scour around the structure.

The scour effect along the shipping canals was more severe than at the lakefront. The water levels in the canals were relatively high, causing a higher loading on the transitions, often resulting in failure of the flood defence, see Figure 8. These transitions are mentioned as a failure mechanism in Dutch codes (TAW 1998), but the disaster in New Orleans showed these are of major importance.

Scour around structures was also observed along the Lake Pontchartrain defences. However, the scour caused hardly any breaches on the system. The major part of the lakefront defences performed well, indicating that the conditions were relatively less severe than the Lake Borgne and shipping canal conditions. The only points of attention were scour spots around objects in the earthen embankment (fences, staircases) and other local different circumstances (below a bridge). This problem is merely a maintenance problem; maintenance should be aimed at assessing and improving these points.

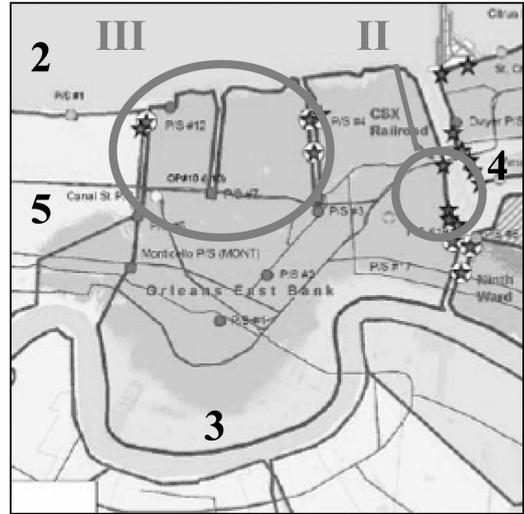
The Orleans East Bank is bordered by Lake Pontchartrain on the north ('2' in Figure 9), shipping canals on the east ('4'), the Mississippi River on the South ('3') and high grounds on the west ('5'). Several failures were observed along the shipping canals; failure

Figure 9. Orleans East Bank dike ring (modified after ILIT 2006).

of floodwalls and the failure of a sand-bag wall that replaced a broken gate ('II' in Figure 9). However the major part of inundation was caused by geotechnical failure of floodwalls along dewatering canals ('III').

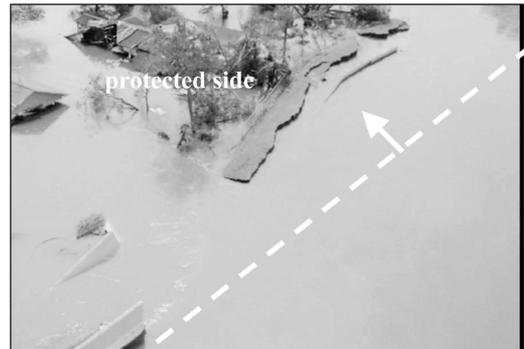
Figure 10. Failure of 17th Street Canal (modified after ILIT 2006).

As hurricane Katrina passed the city, the wind started to blow from the north, causing the water levels of Lake Pontchartrain to rise on the northern part of the dike ring. This high water levels progressed into the dewatering canals that were constructed to connect the city's pumping stations with Lake Pontchartrain. Three floodwalls breached along two of the dewatering canals, one along the 17th Street Canal and two along London Avenue Canal. The failure of the 17th Street Canal floodwall got a lot of attention. Pictures show that the dike body was pushed inland horizontally, see Figure 10, most probably due to a combination of weak soils and high water pressures (ILIT 2006). It must be

noted that no evidence has been recovered that the water level exceeded the crest of the floodwall or even the design level.

The original designs (in the 1960's) did consider the instability, however not all possible failure planes were taken into account. Besides, the highly variable subsoil, in combination with design calculations based on expected values (instead of quantiles) played an important role. The sub-soils at the failure location were 20% weaker than adjacent sections (IPET 2006).
