## Lessons from New Orleans for the design and maintenance of flood defence systems

W. Kanning, S. van Baars, P.H.A.J.M. van Gelder & J.K. Vrijling

**ABSTRACT:** The flood disaster of New Orleans due to hurricane Katrina in August 2005 can provide valuable lessons for the design and maintenance of European flood defence systems. The system partially failed because the design conditions (water levels, waves) were exceeded by the hurricane. The other part of the system failed at water levels below design level due to geotechnical failure of the floodwalls' foundations. The disaster showed the importance of a careful determination of design conditions, the significance of transitions and objects on the slopes and it showed that geotechnical failure is of major importance for the reliability of flood defence systems.

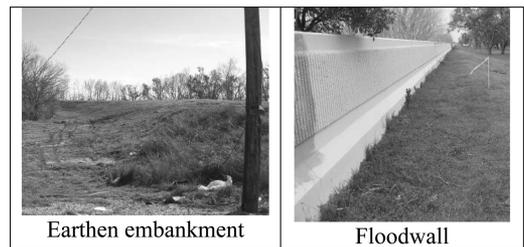
Figure 4. Two types of flood defences in New Orleans.

dike ring areas are considered: Orleans East Bank ('A' in Figure 3), Orleans East ('B') and St. Bernard ('C'). Furthermore, a distinction has to be made between two types of flood defences: earthen embankments and floodwalls, see Figure 4. Other words for flood defences are levees (in the USA) or dikes (in the EU). Failure is defined as: a flood defence that loses its water retaining function.

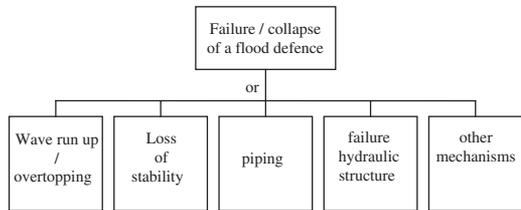
Figure 11. Failure tree of a flood defence with most important failure mechanisms (based on TAW 1998).

Wave run up/overtopping is caused by high water levels and/or waves, resulting in erosion of the inner slope and finally a breach. In Dutch flood defence regulations, the mechanisms of wave run-up and overtopping is assumed to contribute most to the total probability of failure of a flood defence system. Loss of stability occurs when the structure undergoes large deformations due to a load that is higher than the resistance; this can be micro or macro stability. Failure due to piping occurs when soil particles are washed out below the structure due to seepage. Failure of a hydraulic structure occurs when the strength/stability is insufficient (structure, foundation or transition) or when the moveable parts of the structure fail due to not closing or due to a water level that is higher than the top of the structure. Piping, loss of stability and failure of a structure due to insufficient strength or stability is usually referred to as geotechnical failure.

- Overflow/overtopping (root 1 in Figure 11)
- Failure hydraulic structures (root 4 in Figure 11; a combination of overflow and insufficient stability of the structure and its foundation)

- Transitions around structures, not in Figure 11, but identified in Table 1.
- Overflow/overtopping (root 1 in Figure 11)
- Failure hydraulic structures (root 4 in Figure 11; a combination of overflow and insufficient strength/stability of the structure and its foundation)

- Horizontal sliding (See Table 1 and root 2 in Figure 11)
- Failure of hydraulic structures due to a combination of piping and reduced stability (boxes 3 and 4 in Figure 11).
- Failure hydraulic structures (root 4 in Figure 11; a combination of overflow and insufficient strength/stability of the structure and its foundation and the non-closure of a structure)
